# AERONAUTICAL INFORMATION CIRCULAR 024/2026

## TORONTO/LESTER B. PEARSON INTERNATIONAL AIRPORT (CYYZ) REVISION TO AIRPORT HOT SPOT INFORMATION

(Replaces AIC 022/2026)

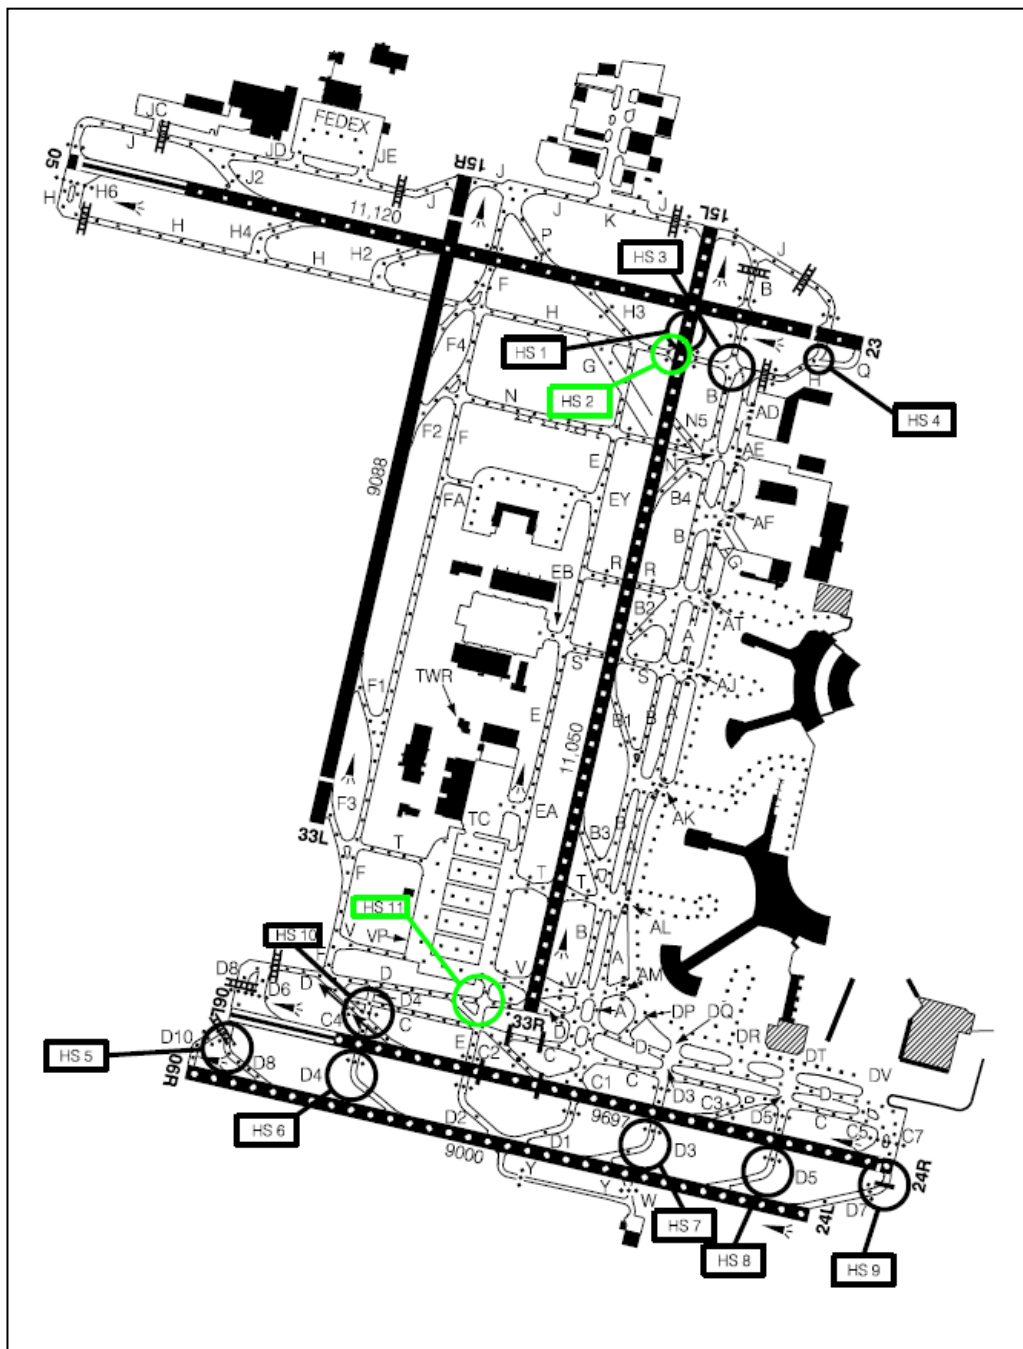
Figure 2.

HS 2 – Taxiing eastbound on twy H aircraft fail to hold short of and incur on rwy 15L/33R.

HS 11 - Taxiing eastbound on twy D aircraft miss turn onto twy E and incur on rwy 15L/33R

Taxiing eastbound on Taxiway H, aircraft may fail to hold short of and inadvertently enter Runway 15L/33R.

Taxiing eastbound on Taxiway D, aircraft may continue beyond Taxiway E and inadvertently enter Runway 15L/33R.

The revised CYYZ Airport Hot Spot Diagram accompanies this circular and depicts the locations of the new HS 2 and HS 11.

- taxi operations eastbound on Taxiway H approaching Runway 15L/33R.
- taxi operations eastbound on Taxiway D approaching Taxiway E.
- runway holding position markings, signage, and lighting.
- airport moving map displays, where available; and
- compliance with all ATC instructions.
